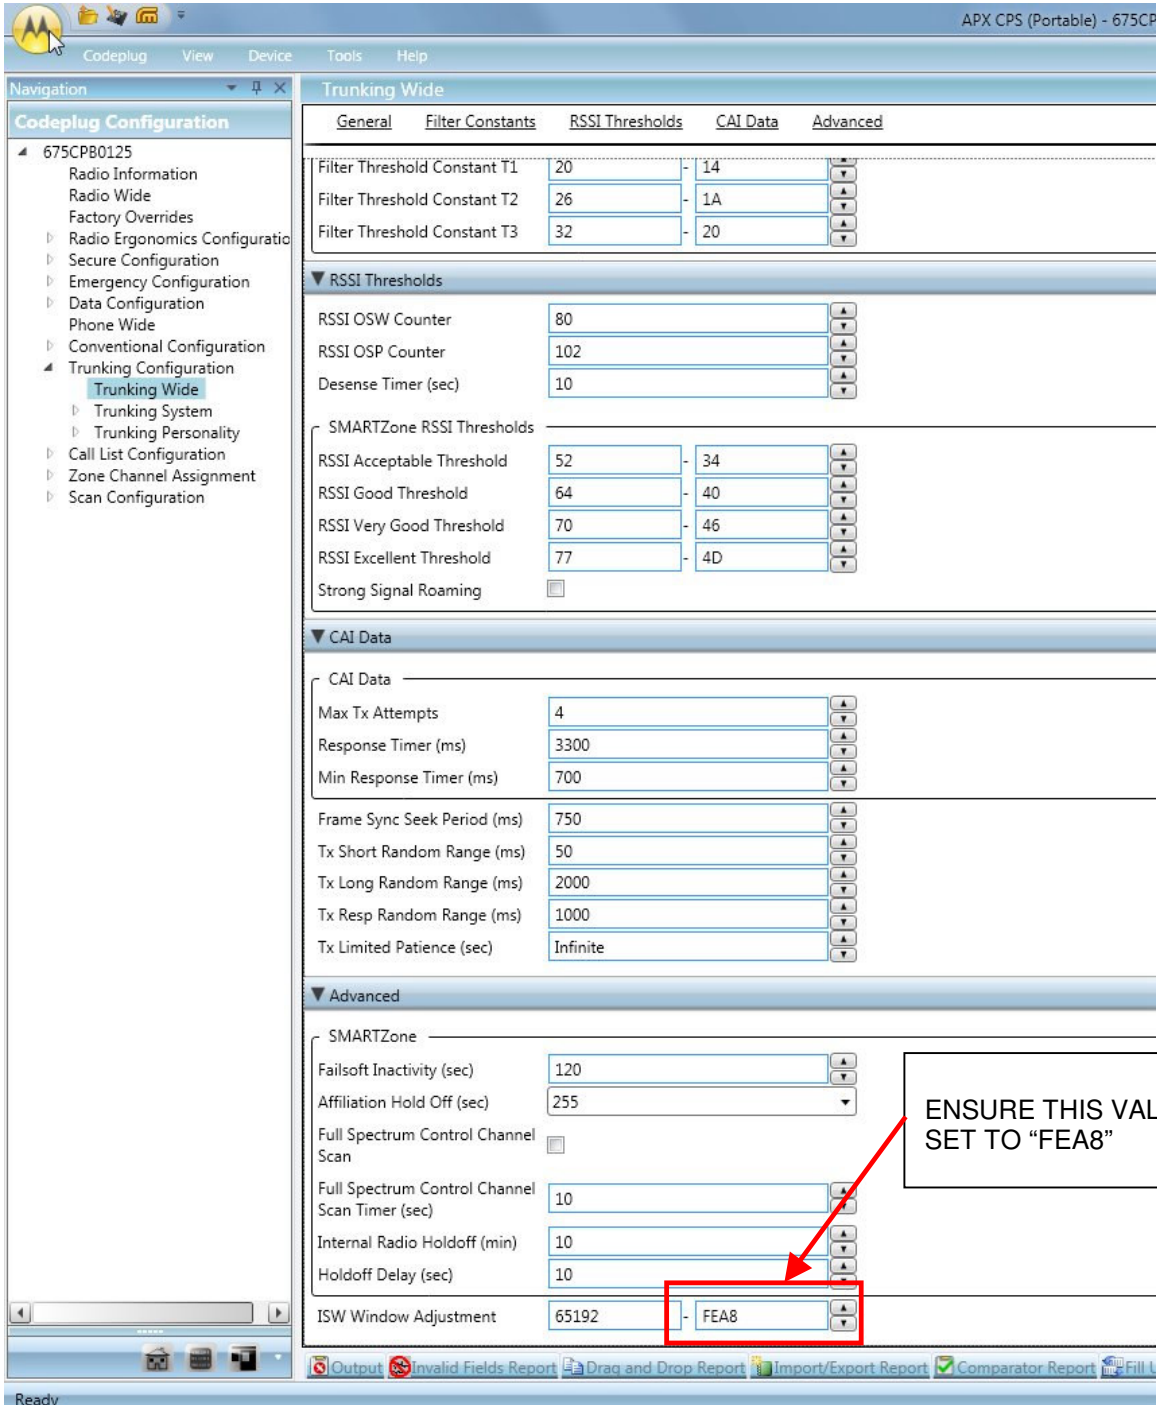
FIGURE 1 CORRECT TRUNKING ISW VALUE

Check the “ISW Window Adjustment” timing value. If the programming was cloned over or dragged over from another radio that is different, like the APX 7000 or an APX mobile, then this value may have been overwritten with the wrong value. This may cause the radio to not log on to the trunking system. For APX 8000 modules, use the value specified below.
